Outboard Gearcase Technician's Guide

Section 1 - General Gearcase Information

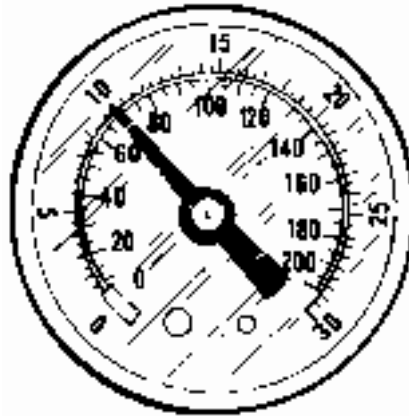
3. Rotate drive shaft, prop shaft and move shift rod, while housing is pressurized to check for leaks.

4. If pressure drop is noted, immerse housing in water.
5. Re-pressurize to specification and check for air bubbles.
6. Replace leaking seals as necessary. Retest housing.

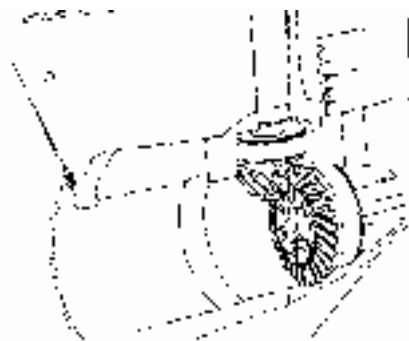
A quiet gear design was introduced in 2003 MY. .The 75/90 has a gear ratio change to 2.33:1 (12/28) from 2.07:1 (14/29). Refer to Outboard Service Bulletin 2002-01 for introduction (propeller chart changes). There are also owners manual and service manual changes.

Decal Number	Gear Teeth Pinion/Forward	Gear Ratio
12	12/28	2.33:1
14	14/29	2.07:1

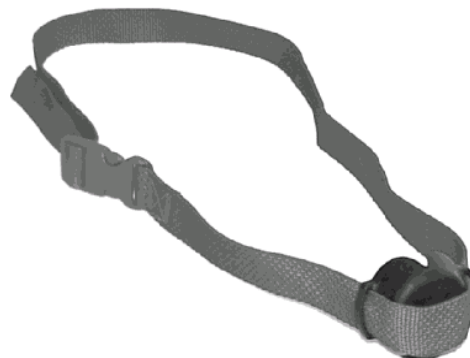
P/N 881150Q 1 or 881150K 1

- Used to cover the front inlets of the 3.0 Liter dual water inlet lower units.
- The cover will prevent air from being drawn into the front inlets when engine is being run using the side water inlets only.

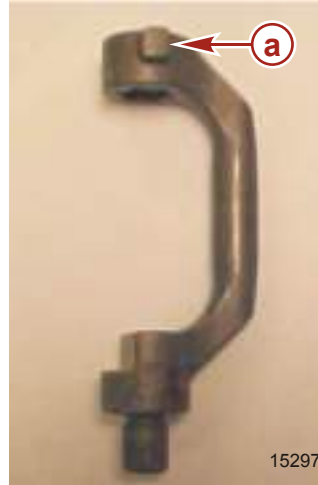
The shift crank in a standard rotating gear housing has the locating tab facing aft towards the propeller of this gear housing. In counter rotating gear housing, the locating tab faces towards the bow of the boat.

a - Locating tab

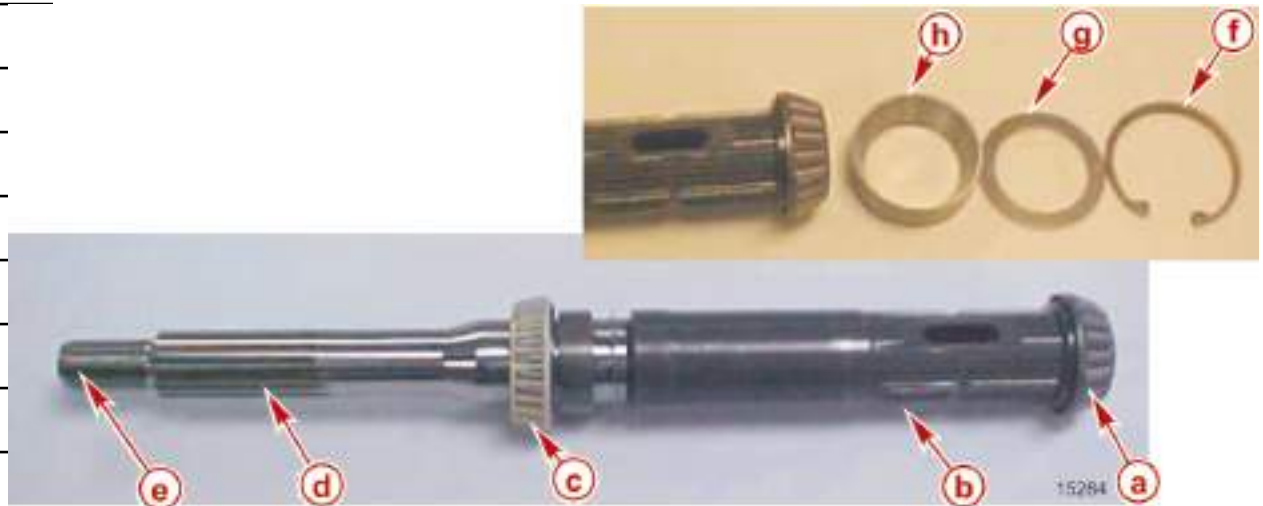
- The prop shaft and clutch have additional splines for added strength.
- The prop shaft end play has been eliminated by way of a dual taper roller bearing design.
- The tapered roller bearing is packaged as an assembly.
- Gear and propeller shaft assembly can only be removed from gear housing after driveshaft and pinion gear have been removed.

| a - Tapered roller bearing | e - Eliminated end play |

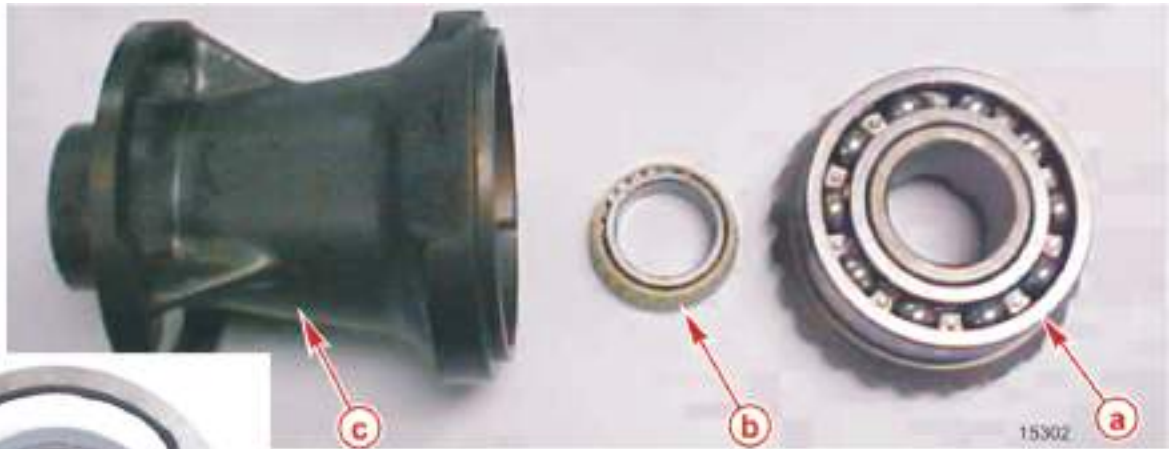
Bearing Carrier and Gear Assembly

- a - Ball bearing
- b - Tapered roller bearing
- c - Bearing carrier

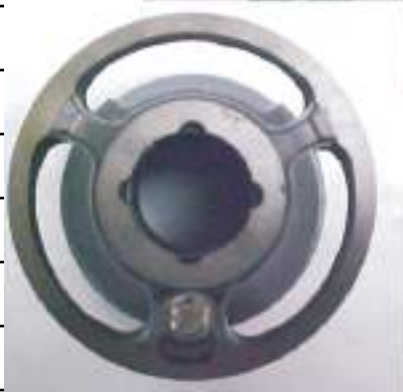
The propeller shaft utilizes two tapered roller bearing and cup assemblies for propeller shaft support. The tapered bearing is behind the bearing carrier seals. The reverse gear assembly on standard gear housing (or forward gear and bearing adaptor on counter rotation gear housing) must be removed from the bearing carrier to gain access to this bearing for inspection. The other tapered bearing is located inside the gear assembly.
